BOATWORKS BLOG

By Reuben Smith, Boatbuilder at Hall's

1928 22' CHRIS CRAFT CADET - "MOONSHINE"

Number 1 in a Series

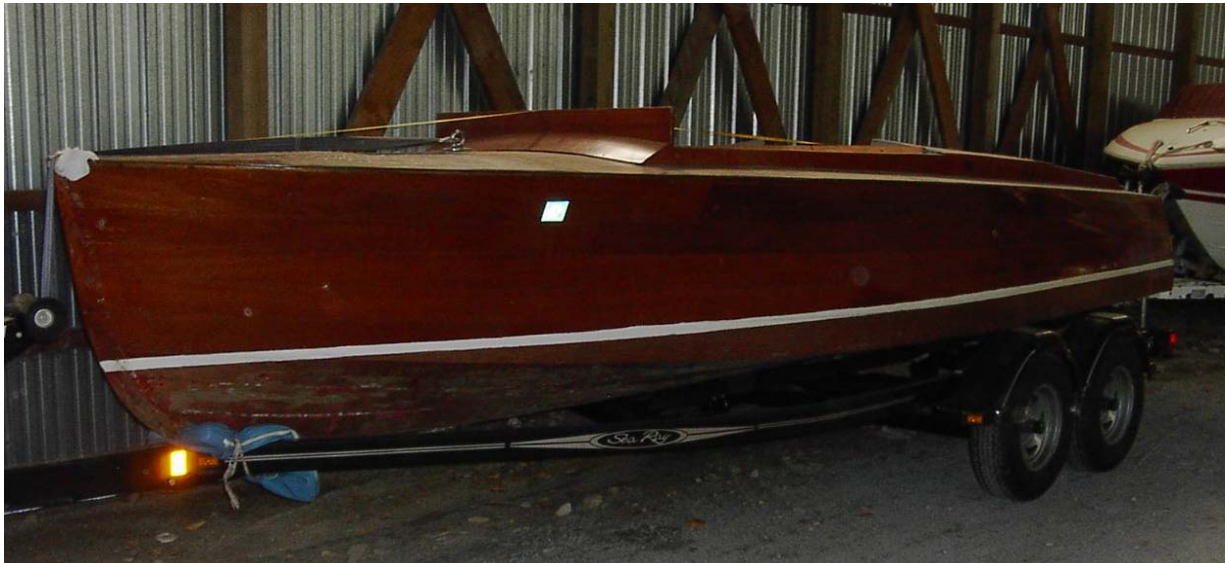
Over the next months, we'll tell the story of Hall's restoration of this cadet. This boat has always lived on Lake George, and at 80 years old, she's in the shop for a structural rebuild and restoration. The boat needs a complete new bottom, with repairs to the stem and gripe, and new bilge stringers, keel, and chines, and all the framing and planking. The original engine is long gone, and the boat will have a restored engine installed when we're finished. Above the waterline, we'll do various repairs to planking, deck, and covering boards, and do a complete strip and refinishing.

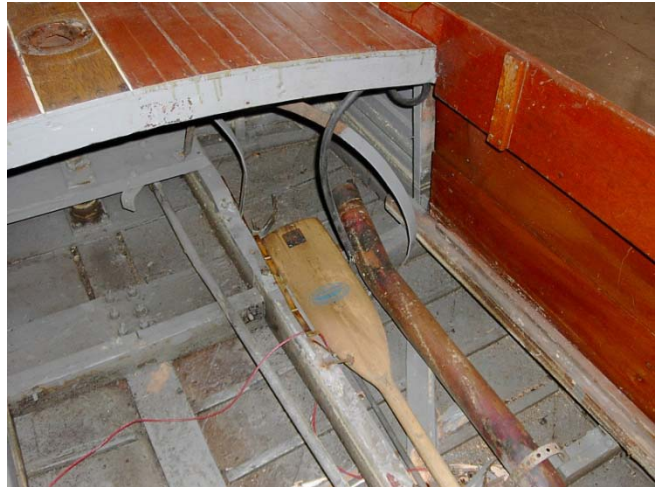
The boat should be photodocumented before restoration. Ideally, the hardware is still on the boat during this, but either way we go through the boat, taking a picture of everything, from every angle, before pulling it apart. I like to have a ruler in the shot, for scale, as well. I don't think any part of the boat is too mundane for a picture. When putting the boat back together, I may be desperate for a detail I didn't expect to need, so I try to be systematic and get everything from a few angles. The pictures are pretty uninteresting, generally, but they may be critically important later on.

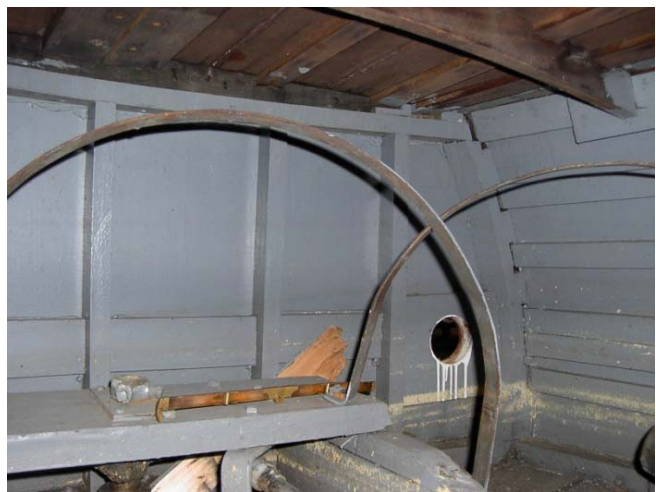
Having a lines plan helps a lot. Unfortunately, the Mariners' Museum, which houses the archives

for Chris-Craft, was moving their collection as this project began (which is going to be terrific for protecting that collection; it was just our hard luck that was going on at our moment of need), and no one we knew seemed to have a lines plan. It's possible, too, that there is no lines plan for the underwater form of a Cadet. But there are Cadets around here with good bottoms, and there is also a generally recognizable shape to a Chris Craft bottom from that era.

We decided to level the boat according to the waterline. Using the waterline as a reference can be risky, because on an 80 year old boat it's been sanded over, rescribed, planks have been replaced, and it's not always been scribed into the wood with the sort of care we'd like. Looking closely at this line, we felt we could see the original scribed line. We shot a laser level from one place on the floor toward 5 different points on the hull: the stem, two points opposite each other about even with the forward seats, and the quarters, just forward of the transom, at the first frame. We had set the boat on jackstands at those points, so it was a simple job of levelling the hull by screwing the stands up or down.
